BRISTOL RESERVOIR DAM
CT. 00008

PHASE I INSPECTION REPORT
NATIONAL DAM INSPECTION PROGRAM

Identification Number:	CT 00008
Name:	Bristol Reservoir Dam
Town:	Bristol
County and State:	Hartford County, Connecticut
Stream:	Pequabuck River
Date of Inspection:	September 21, 1978

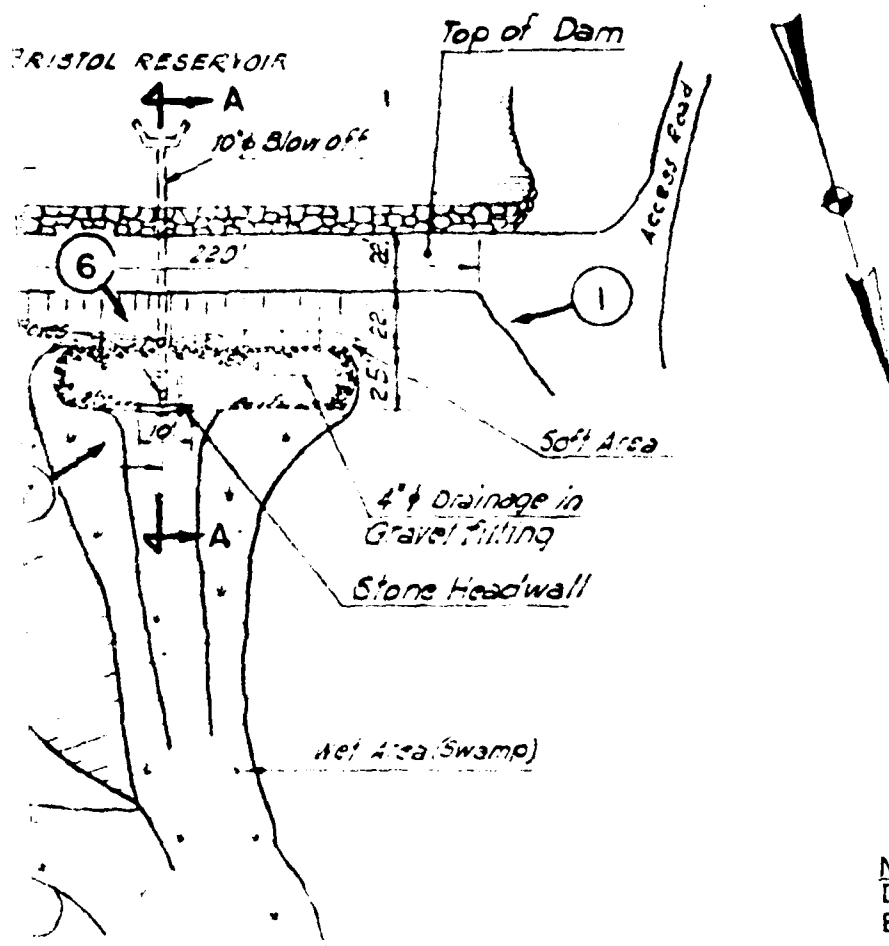
STORCH ENGINEERS BOSTON, MASSACHUSETTS	U.S. ARMY ENGINEER DISTRICT OFFICE CONTRACT NO. W-33-00-0000 DIST. NO. 10000		PLATE-1
	NATIONAL PROGRAM OF INSPECTION OF NON-FEED DAMS		
BRISTOL RESERVOIR DAM		CONNECTICUT	
PEQUABUCK RIVER	SCALE: NOT TO SCALE		
	DATE: Nov. 1974

b. Dam - According to the data sheet supplied from the Bristol Water Department, the body of the dam is composed of earth fill with a stone masonry core. The crest of the dam has no visible bulges or cracks (Appendix B, Plates 1 and 2). Several rodent holes were found on the dam face and soft ground was noted on the downstream slope of the dam (Appendix C, Photo 2). Inspection of the toe showed some seepage, which included several marshy areas that are noted in Appendix B on Plate 1. The seepage water was clear and did not appear to be carrying any sediment. There is an extensive seepage source at the downstream zone of the
